## *Pre-Purchase Marine Survey Report*

Photo 1. Searay 320 Sundancer, year 2003 “XXXXXX”

TYPE OF SURVEY	Pre-Purchase
REPORT NUMBER	320
PREPARED FOR	XXXXXXXXXXXXXXXX
ADDRESS	XXXXXXXXXXXXXXXX
PHONE/EMAIL	XXXXXXXXXXXXXXXX
DATE OF SURVEY	7/25/2007
DATE OF REPORT	7/26/2007
MANUFACTURER/ MODEL	Searay/320 Sundancer

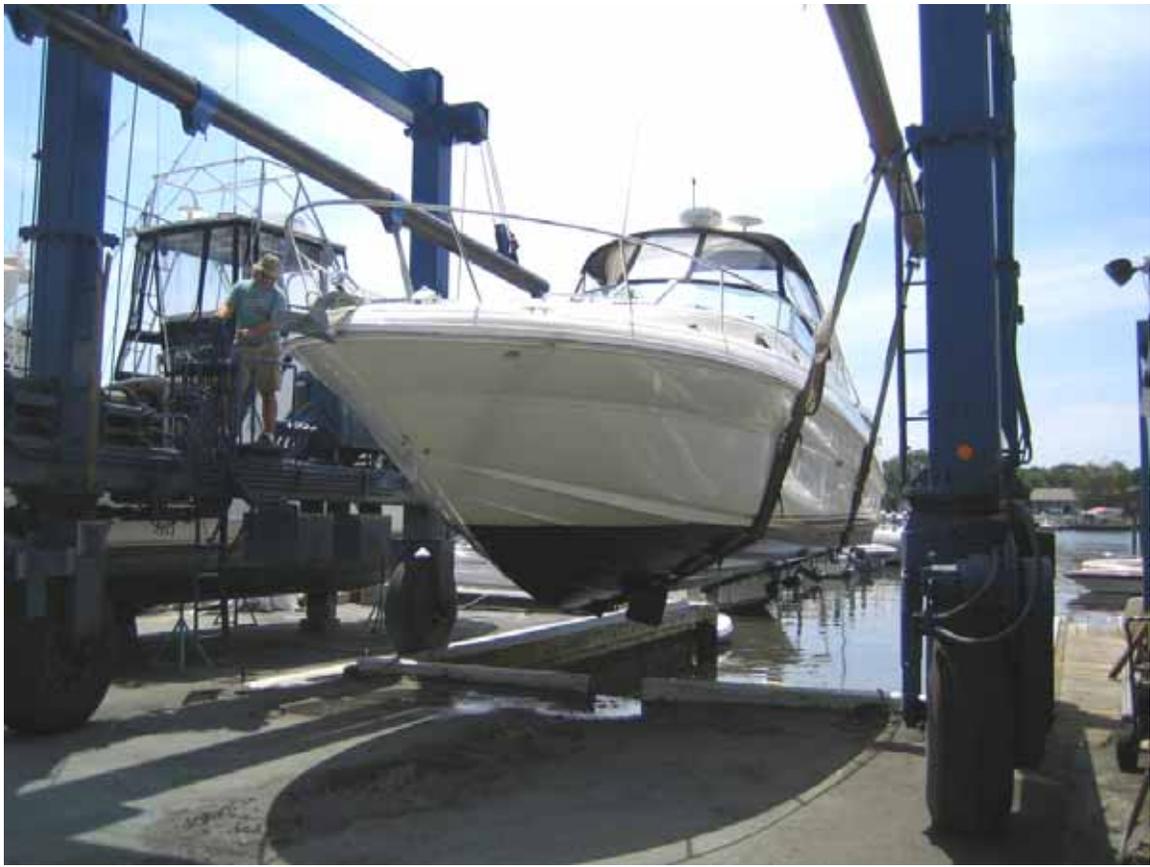
Figure 2. Starboard view.

Minor cosmetic scratches were noted but topsides over-all condition was noted in above-average condition. Average being defined as the typical observed condition of the majority of vessels surveyed built in the year 2003. Gel-coat still retains considerable gloss, although a compounding and waxing is over-due.

<b>FINDING</b>	<b>RECOMMENDATION</b>
Topsides need compounding and waxing.	Have topsides compounded in the Fall after haul-out and waxed in Spring.

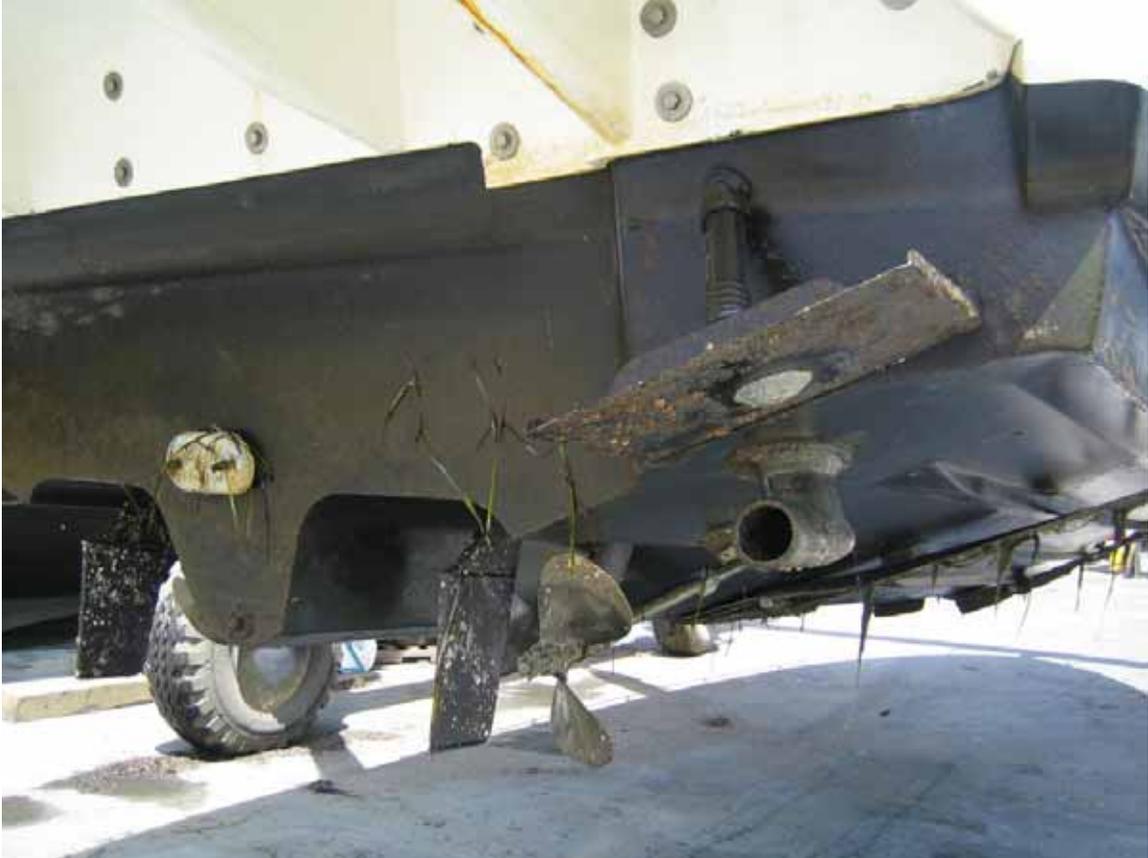
Photo 4. Close-up rudders, props, shafts, struts, trim tab, hull anode.

<b>FINDING</b>	<b>RECOMMENDATION</b>
Excessive toe-in noted in rudders.	Adjust toe-in before next season launch.

DISCUSSION: Rudder parallel adjustment (toe-in) was measured as follows: distance between rudders in front of rudders = 37 inches. Distance between rear edges of rudders = 34 ¾ inches. Alignment should be between zero and ¼ inch difference front to back. Adjustment is made from inside transom by turning steel rod with locking nuts until correct spacing is achieved.

Excessive toe-in causes increased drag, slightly reducing fuel economy and lowers top end speed at wide open throttle.

<b>FINDING</b>	<b>RECOMMENDATION</b>
Moderate marine growth was observed on rudders and props.	Use special bottom paint, specifically designed for immersed metal next season before launch on submerged metal parts.

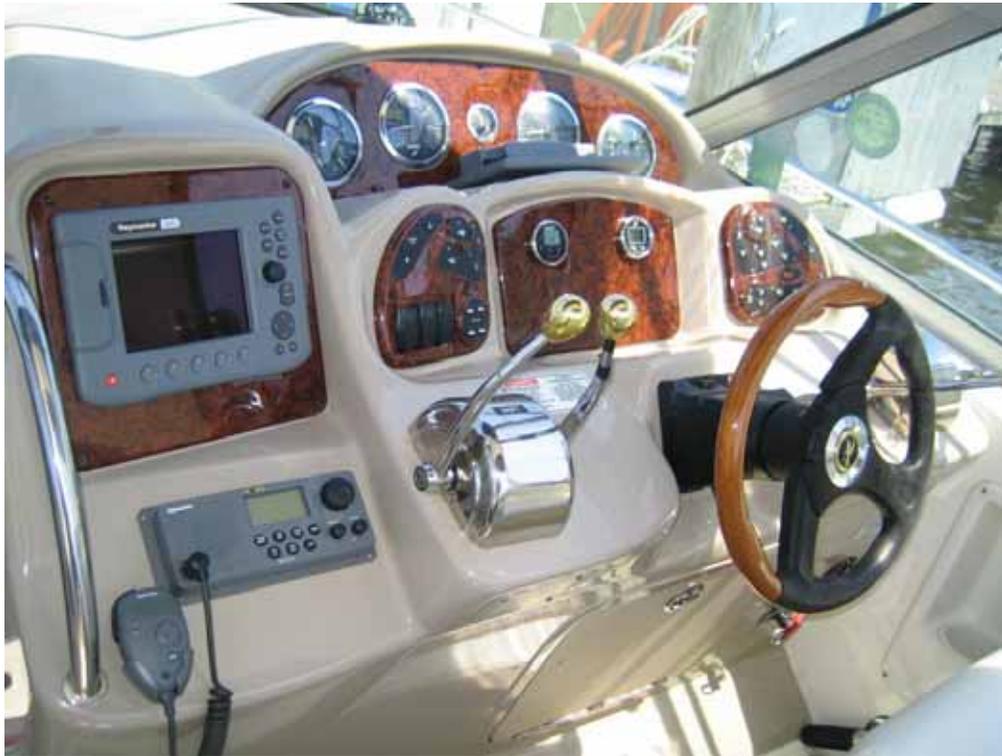
Photo 7. Helm.

Windshield-wipers were tested and operated mechanically but need new blades.

FINDING	RECOMMENDATION
Windshield wipers are damaged.	Replace.

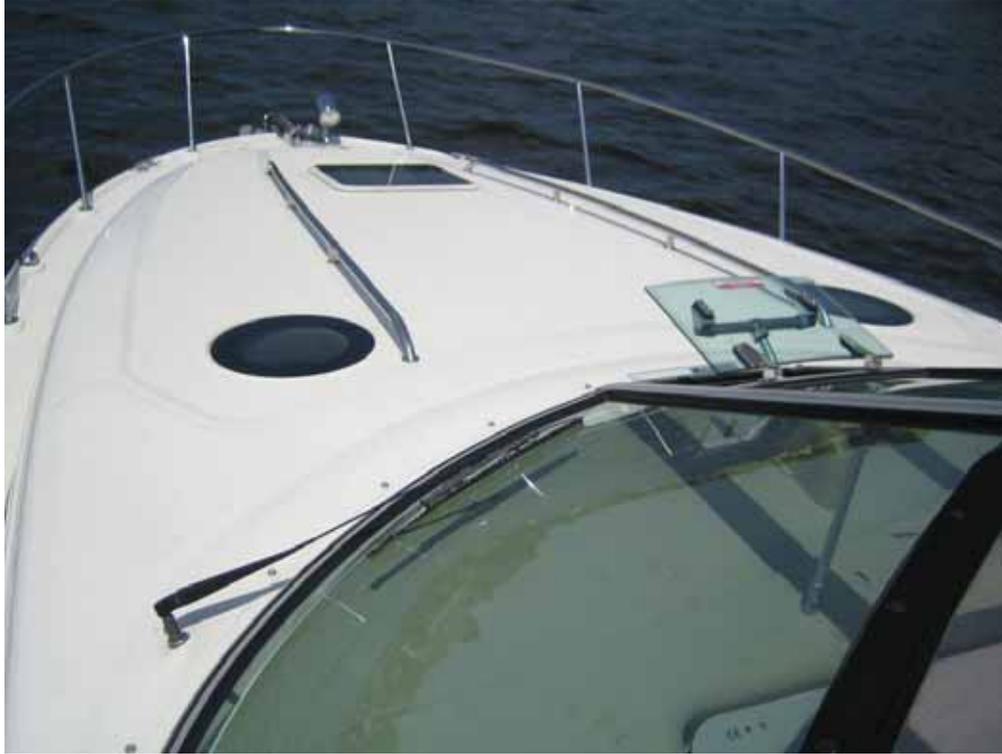
<b>FINDING</b>	<b>RECOMMENDATION</b>
Slight moisture detected on a 10” radius around windlass mostly to port.	Remove windlass, clean and re-caulk area.

DISCUSSION: The most effective way to permanently keep moisture from intruding core under windlass installation would be to drill over-sized holes on deck for bolts, epoxy-fill holes, and re-drill correct size holes through epoxy before caulking to positively seal core.

Photo 8. Foredeck.

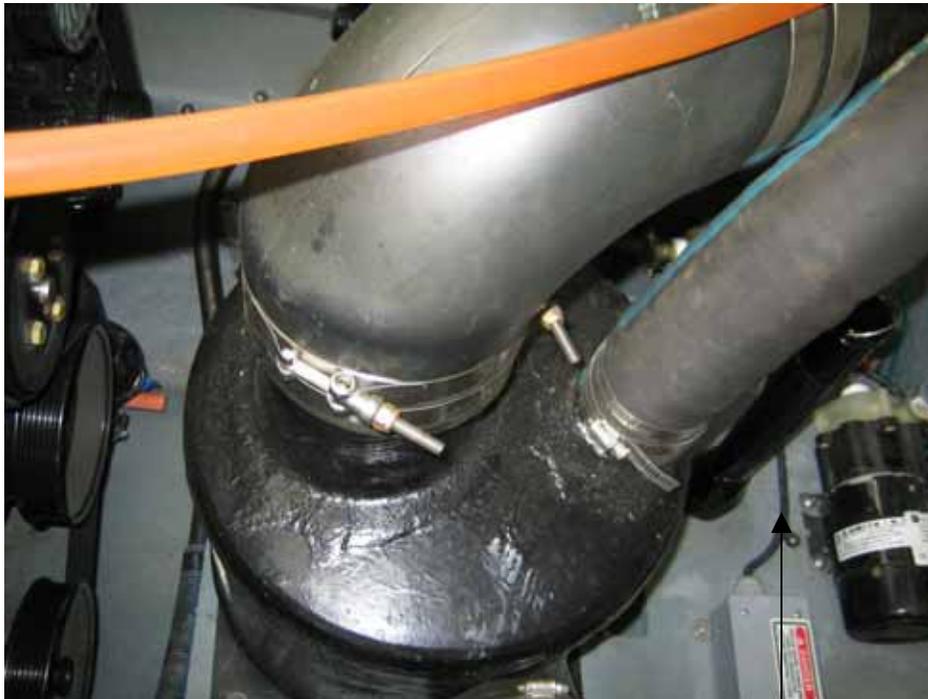
Photo 12. Aqua-lift fiberglass mufflers and hoses in good condition and double clamped.

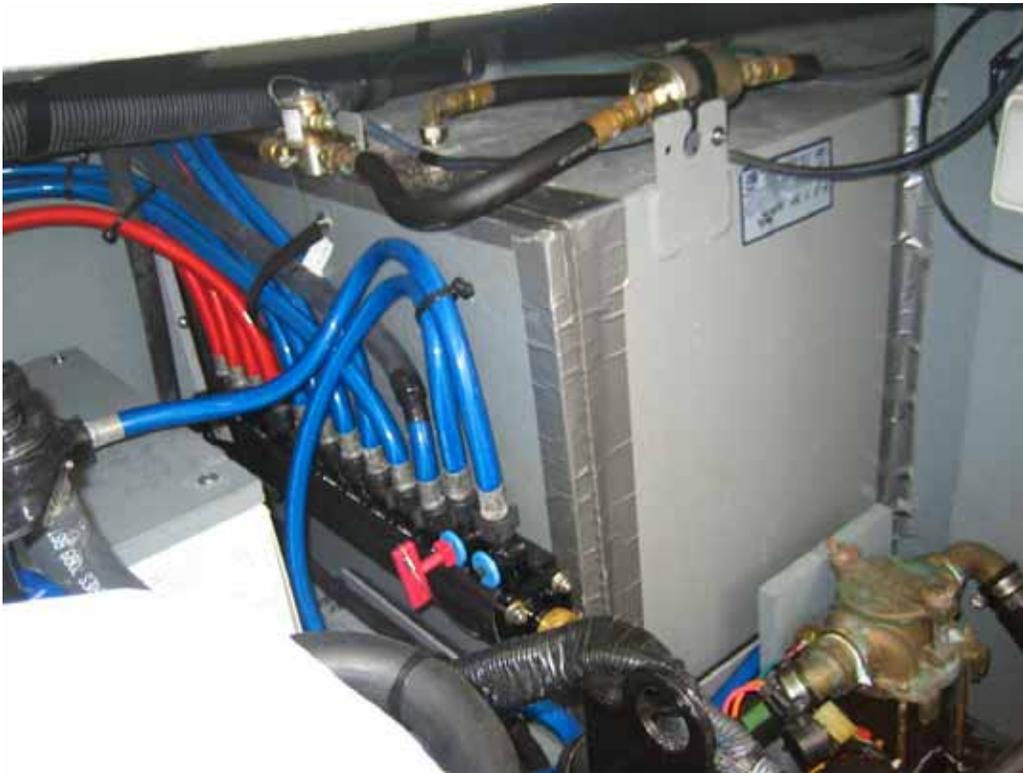
Photo 13. Port side 100 gallon fuel tank properly labeled and vented per ABYC Standards. Fuel hoses are Coast Guard approved and in good condition. Fresh water hot/cold manifold in foreground.

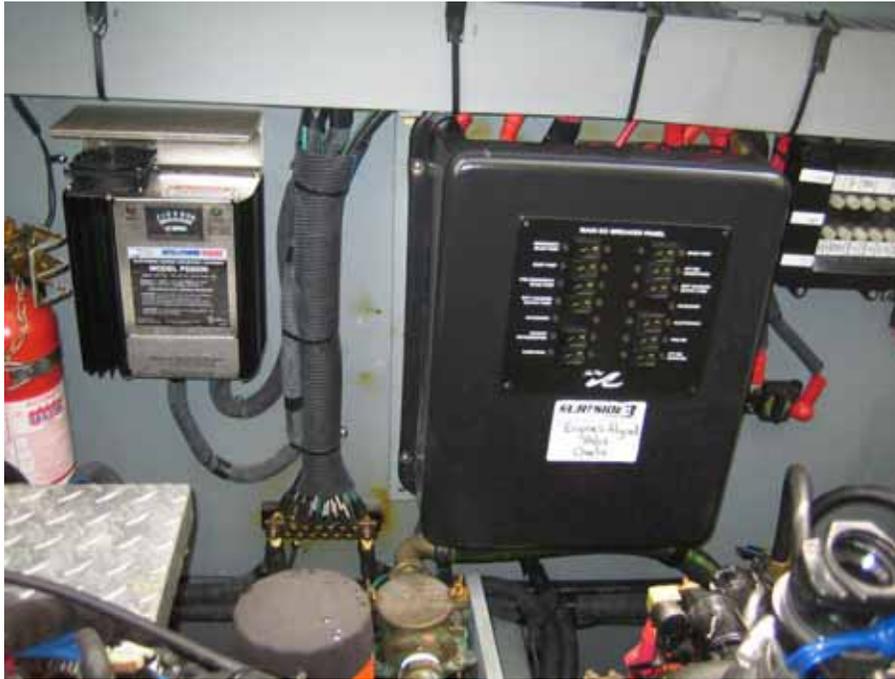
Photo 15. Intelli-power 30A battery charger to left, DC main panel to right.

FINDING	RECOMMENDATION
Battery charger does not power up.	Check fuses and wiring and replace charger if necessary

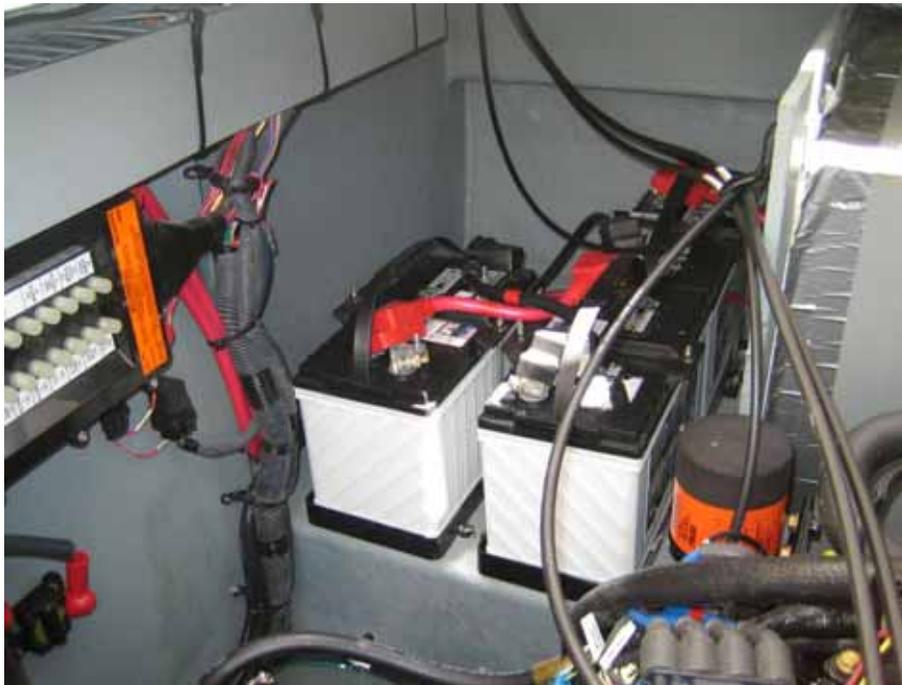
Photo 16. Three group 27 batteries were noted to starboard in engine room secured with positive terminal covered as per ABYC Standards. One is the house battery and the other two are port and starboard starting.

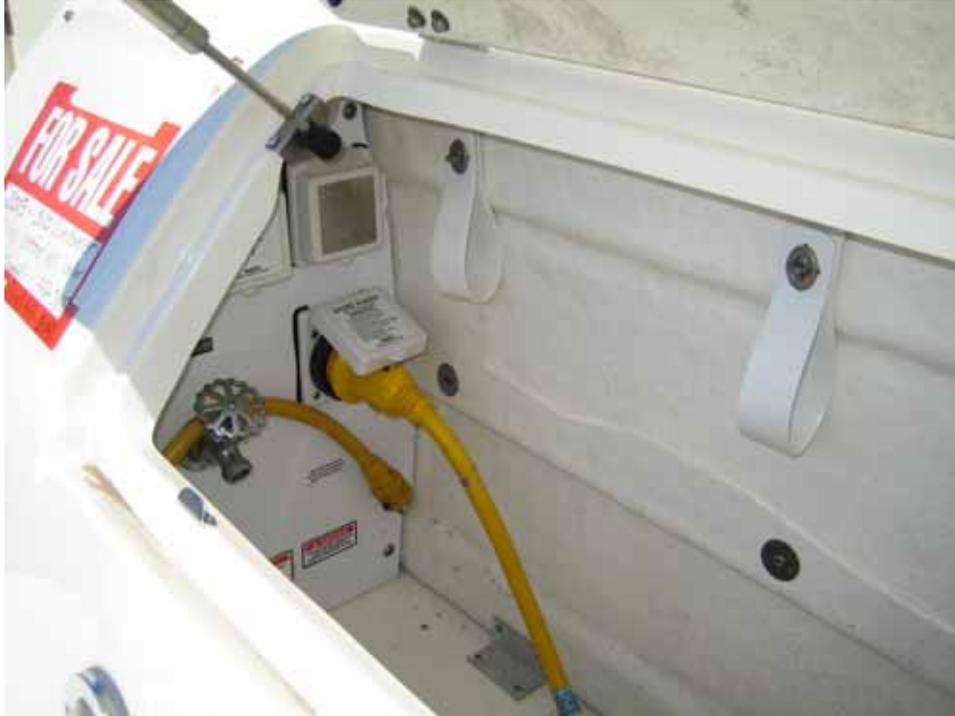
Photo 17. Inlet for 30A power installed to ABYC Standards and tested operational with multi-meter.

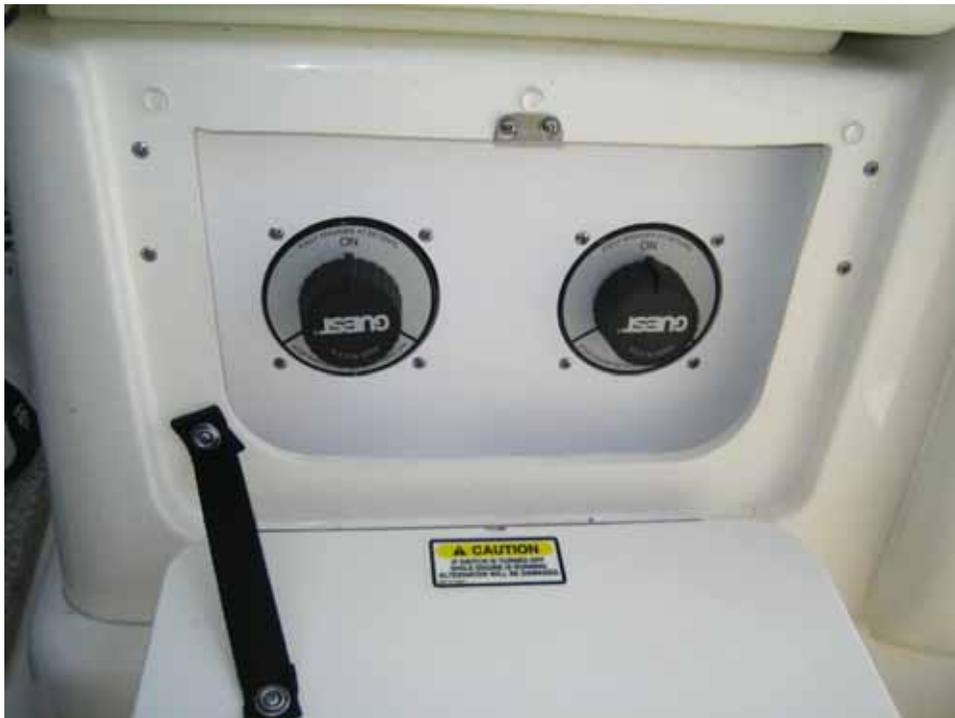
Photo 18. Battery switches under helm seat installed as per ABYC Standards.

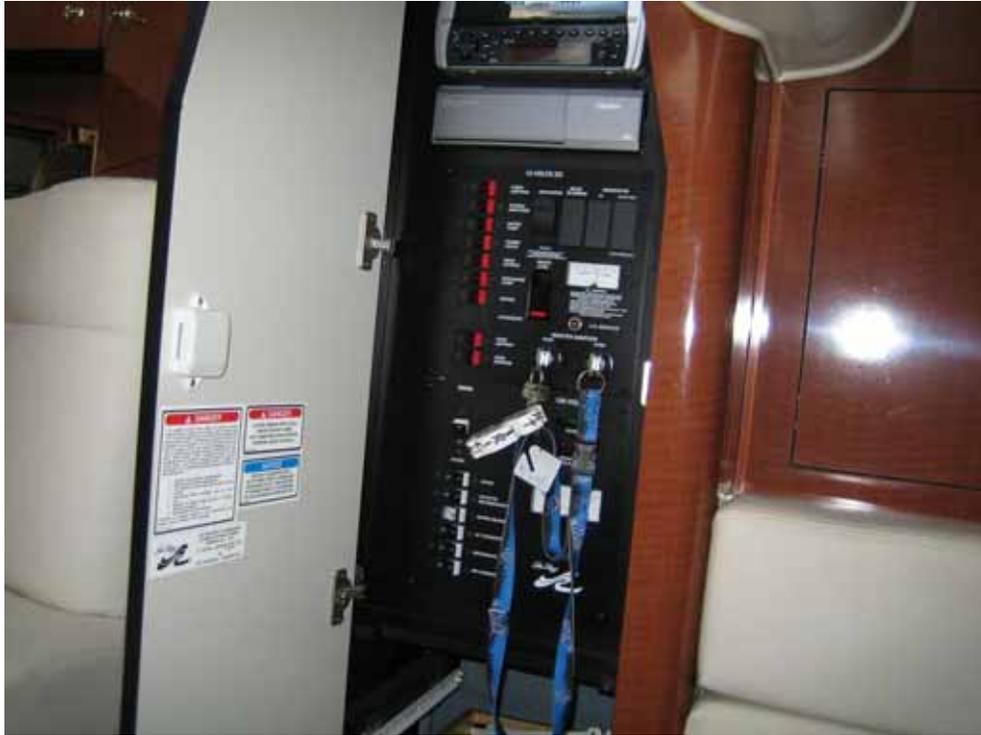
Photo 19. AC/DC breaker panel is installed in cabin as per ABYC Standards. Stereo visible above panel tested working.

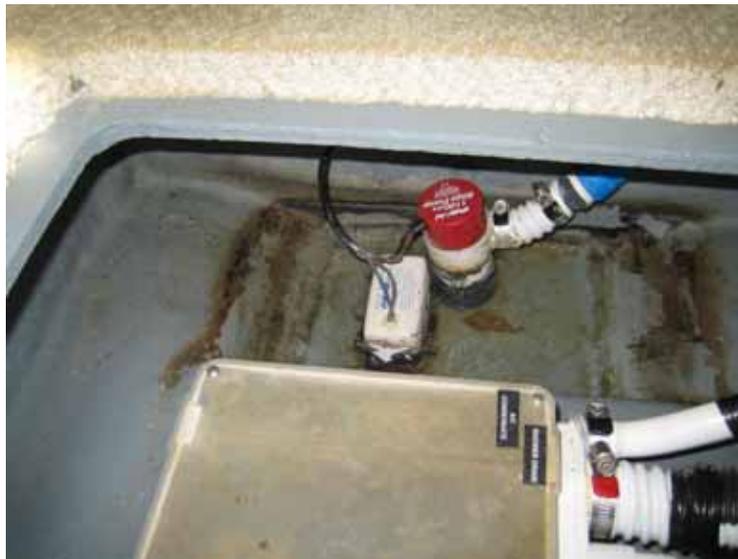
Photo 21. Bilge pump aft in engine room tested working.
